# Voluntary Implementation of Forestry Best Management Practices in East Texas

**TEXAS A&M FOREST SERVICE**

December 2015

*Results from Round 9 of BMP Implementation Monitoring  
2013-2015*

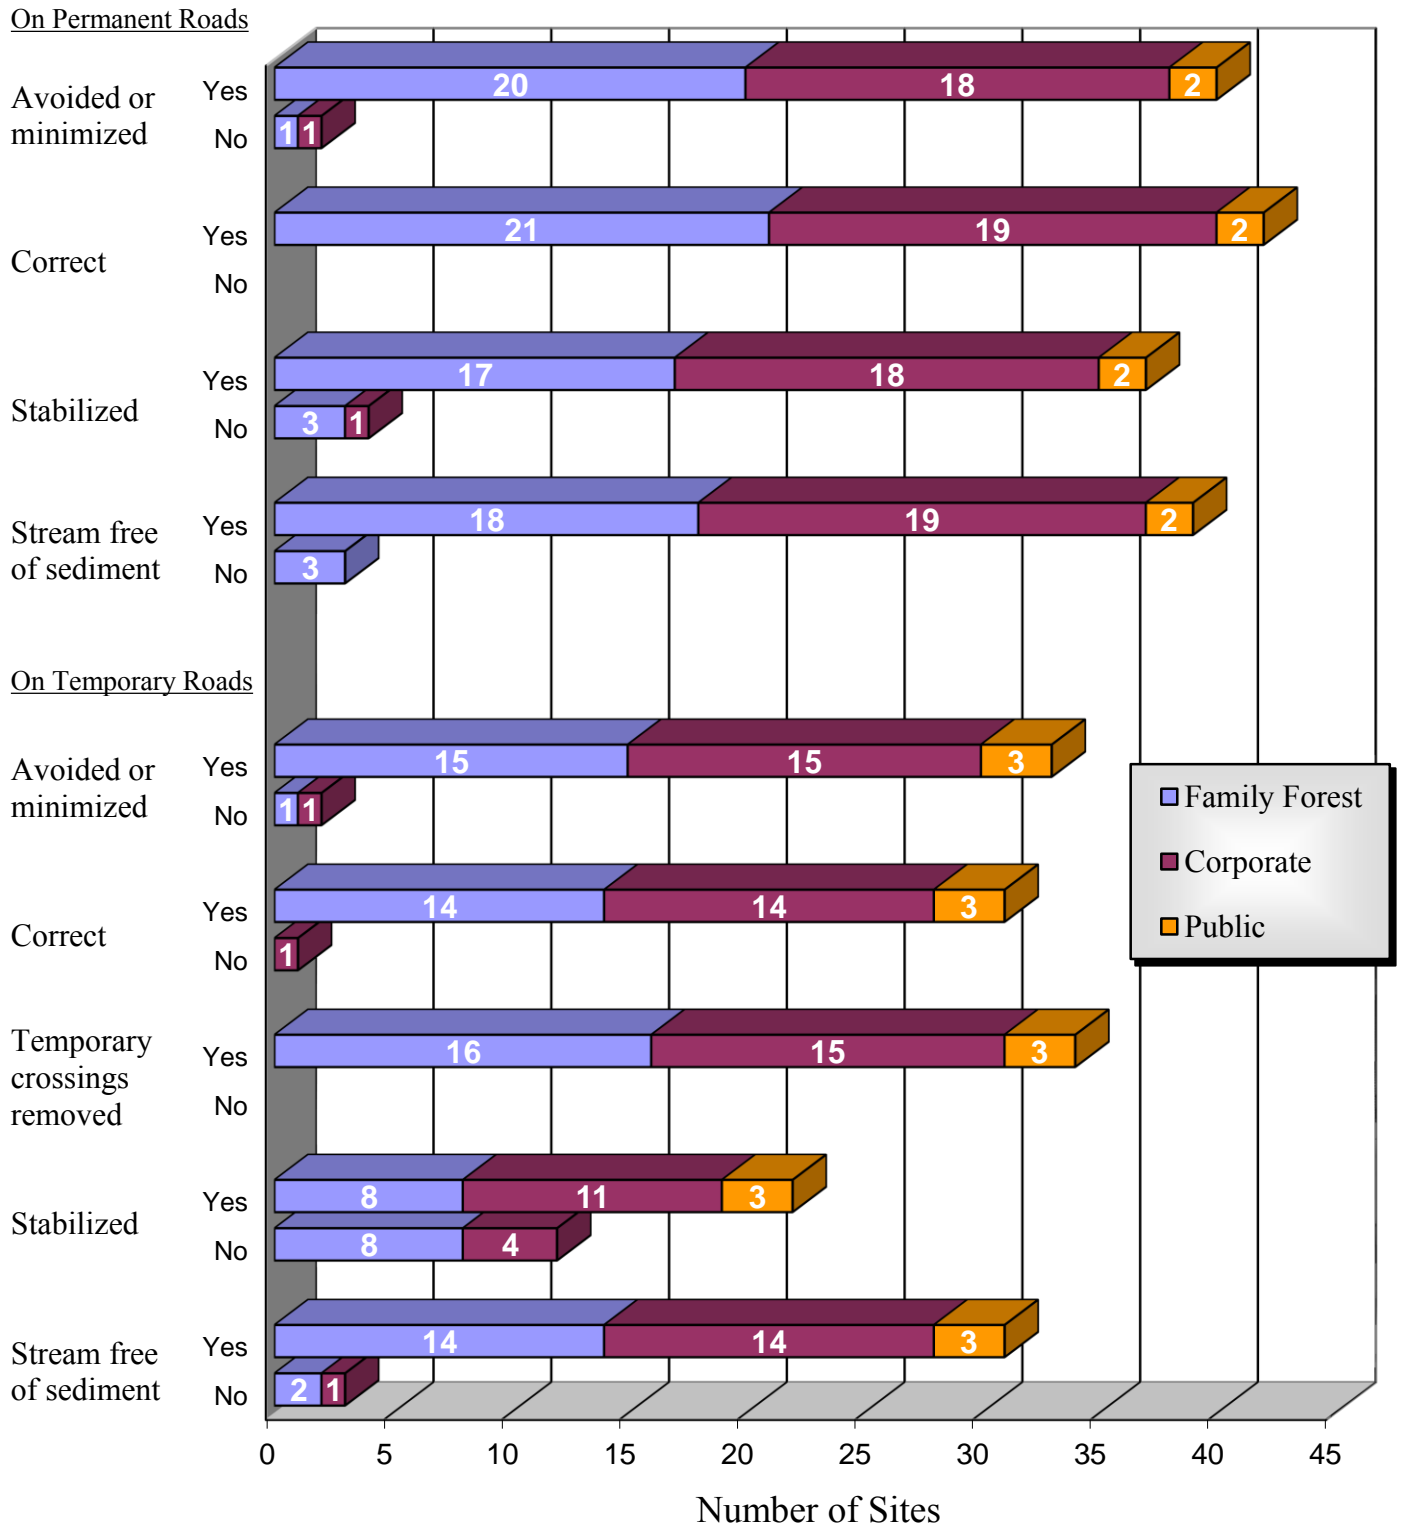
Figure 4. BMP Implementation on Stream Crossings by Ownership Type.

Stream crossings were evaluated on 51 sites. Sixteen sites had crossings on permanent roads only, 9 had crossings on temporary roads only, and 26 had crossings on both permanent and temporary roads. The percent implementation for stream crossings was 92.0% with no significant risks. Within this category, the lowest implementation score for stream crossings on both permanent and temporary roads was stabilization of crossings (90.2% on permanent roads, 64.7% on temporary roads). The highest implementation on permanent roads was for correctness (100%); for temporary roads, it was for removing temporary crossings (100%). See Table 4 and Figure 4.

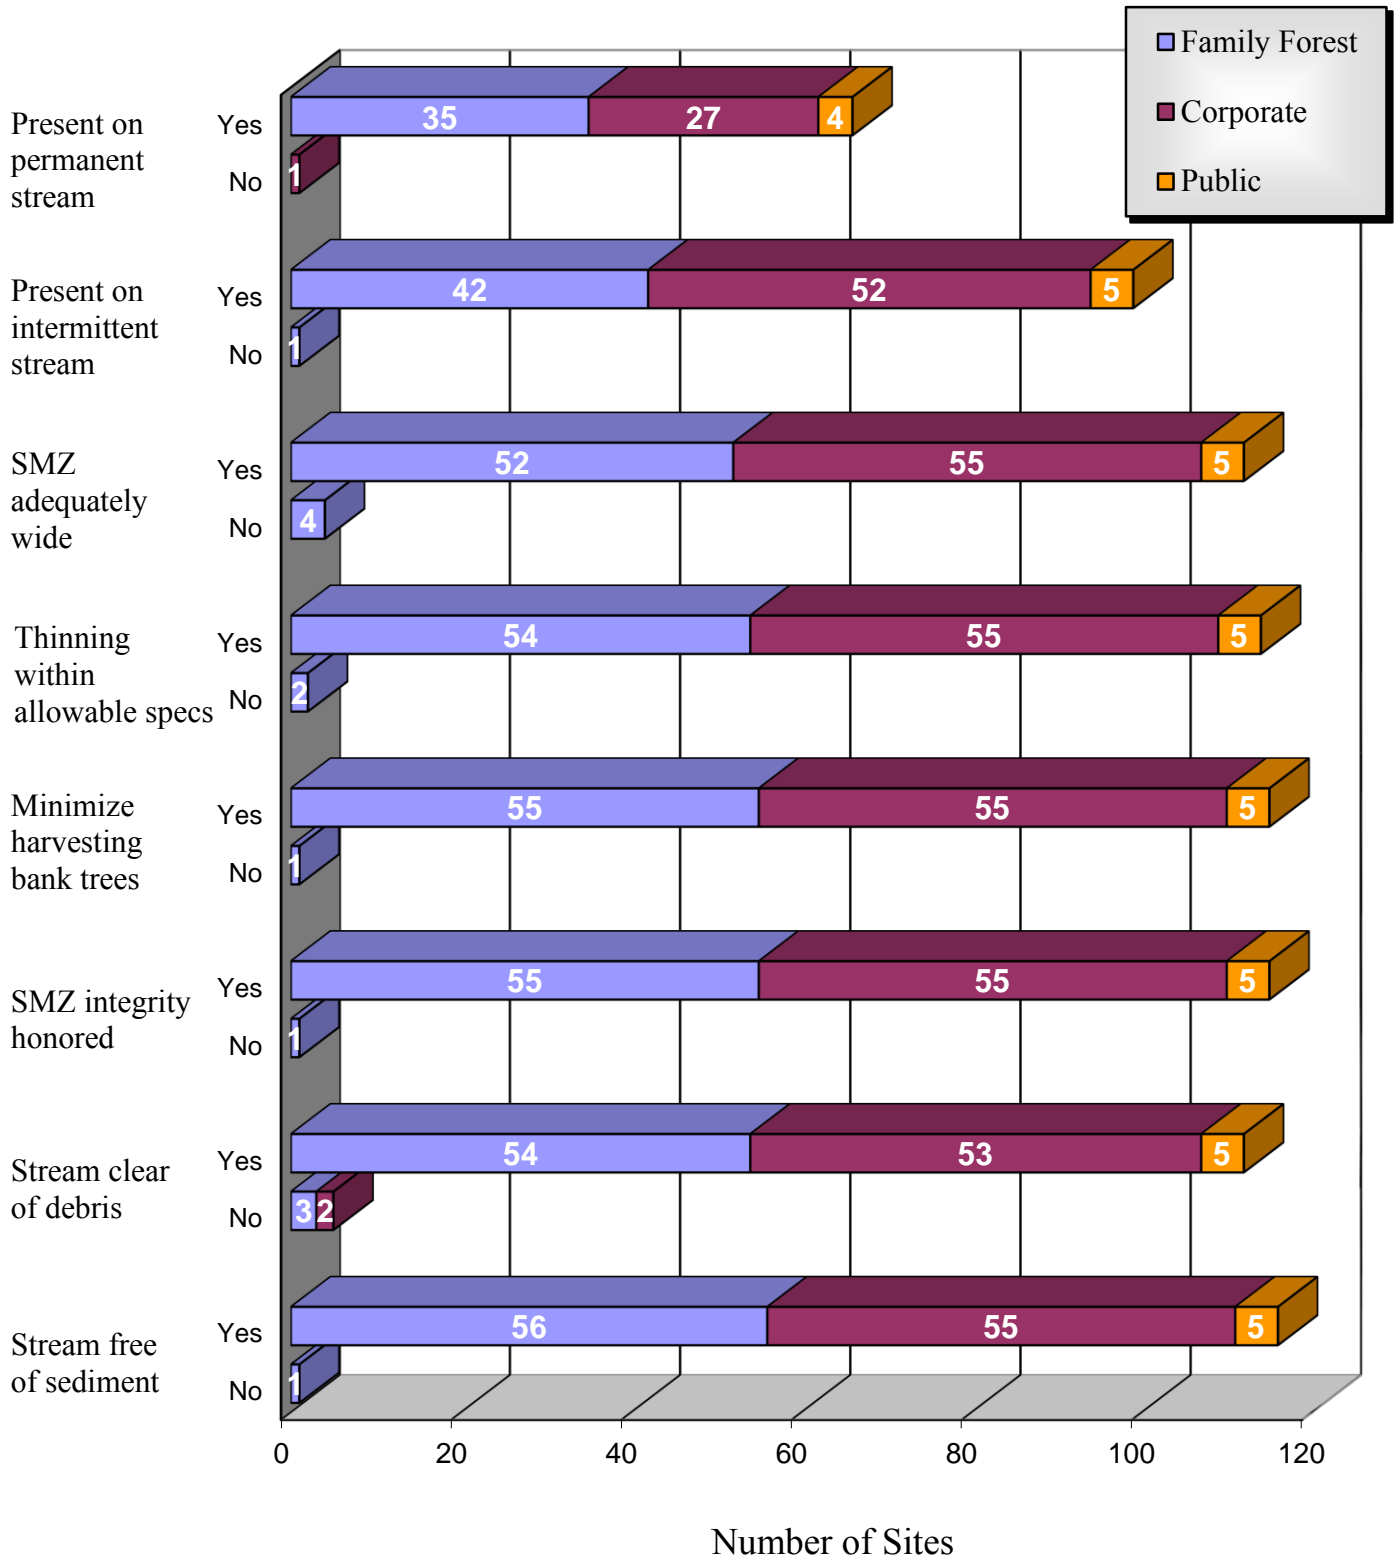
Figure 5. BMP Implementation on Streamside Management Zones by Ownership Type.

Streamside management zones (SMZs) are recommended on all perennial and intermittent streams. All sites with either a perennial or intermittent stream were evaluated for the presence and adequacy of SMZs. Streams were present on 118 of the 150 sites. Of these 118 sites, 23 had perennial streams only, 57 had intermittent streams only, and 38 had both perennial and intermittent streams. The percent implementation for SMZs was 98.2% with no significant risks. Within this category, the lowest implementation was for stream clear of debris (95.7%), while the highest scores were for stream free of sediment, SMZ integrity honored, and minimize harvesting bank trees (99.1%). See Table 5 and Figure 5.

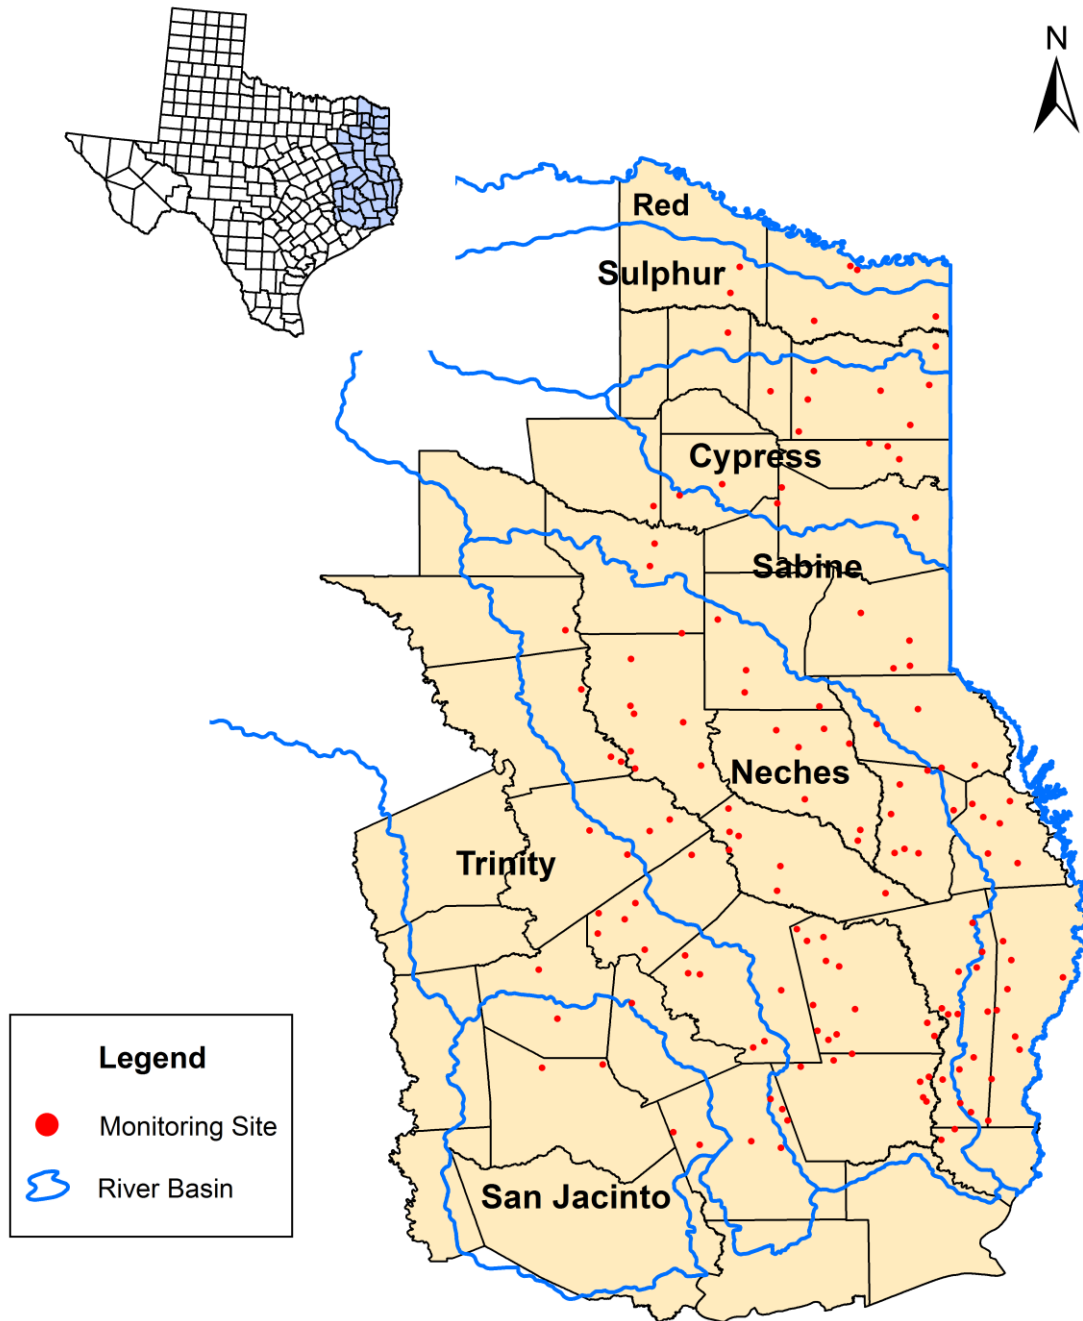
Figure 11. Site Location by River Basin.

Monitoring sites were located in the following river basins: Cypress, Neches, Red, Sabine, San Jacinto, Sulphur, and Trinity. BMP implementation was highest in the San Jacinto River Basin (95.0%, 1 site) and lowest in the Red River Basin (87.5%, 2 sites). See Table 10 and Figure 11.
